Assessment of Chimneys and Roof Structure  
at  
Stenton Mansion  
Philadelphia, PA

Prepared by  
Materials Conservation  
March 2020

In February of 2020, Materials Conservation was contracted to conduct a survey and analysis of Stenton's chimneys and accessible roof structure, to be executed during the imminent re-roofing project on the mansion. MC employees conducted this investigation on February 26th and 27th, during which two mortar samples were taken from the chimneys for gravimetric analysis, four RILEM tests were conducted on two brick joints and two brick faces, wood samples were extracted from the roof structure for species identification, several historic nails were extracted & collected for analysis, marriage marks incised in the roof framing were recorded where exposed, and the general condition of the chimneys, roof structure, and dormers were noted. Due to availability of scaffolding and exposed roofing, only the northwest and southwest sides' roof framing were accessible. This physical investigation was supplemented by archival research at the Athenaeum in Philadelphia, the Philadelphia Historical Commission, and the Winterthur archives in Delaware.

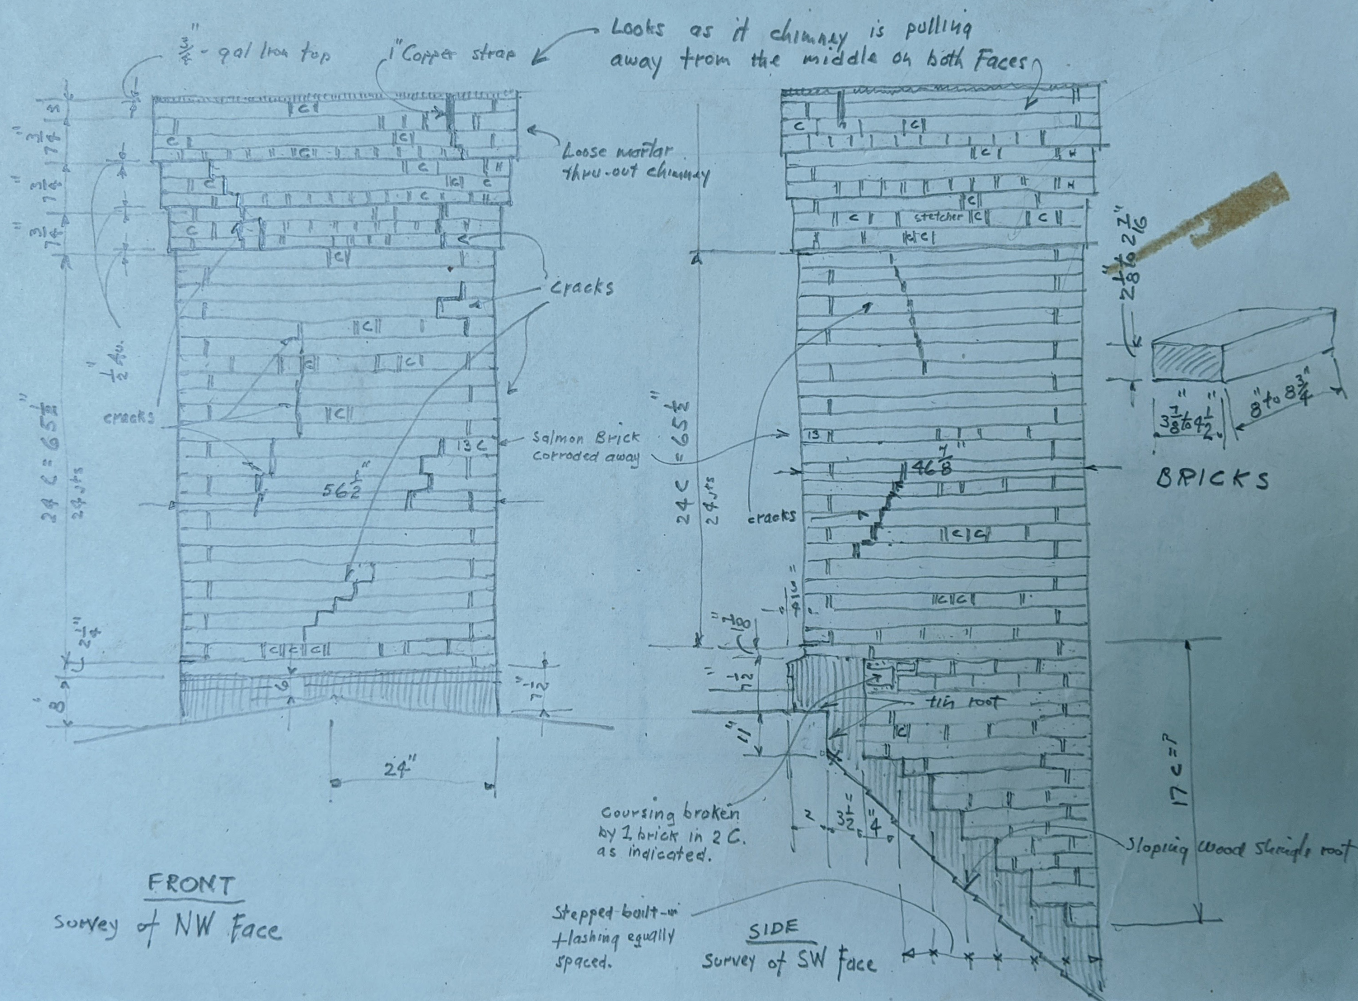
In July of 1958, Brumbaugh sketched a condition assessment of the exterior faces of the two chimneys on the main house. This assessment noted several cracks, loose mortar throughout, exposed brick faces, and noted that the top portion of the chimneys were pulling away from the center. In a letter dated October 20, 1958 from Brumbaugh to the Chairman, he notes, "Kindly note that it was necessary to remove both chimneys to below the roof, and entirely rebuild them. This was discussed with you, as Chairman of the Committee, when the conditions were uncovered, and your approval attained." This demolition and subsequent reconstruction appears to have been in reaction to the conditions found during his assessment. Below the roof line, the Cornell workers cut through the third floor plaster ceiling to provide access for the heating contractor, reinforced the 3rd floor ceiling from collar beams, and cut into the lower portion of the chimneys to insert the air ducts for the heating units. After the units were installed, the 3rd floor ceiling was replastered.

Figure 3 - Condition assessment sketch of 2 faces of the southeast (garden side) chimney, July 8, 1958. Source: G.E. Brumbaugh Paper Collection at Winterthur Library

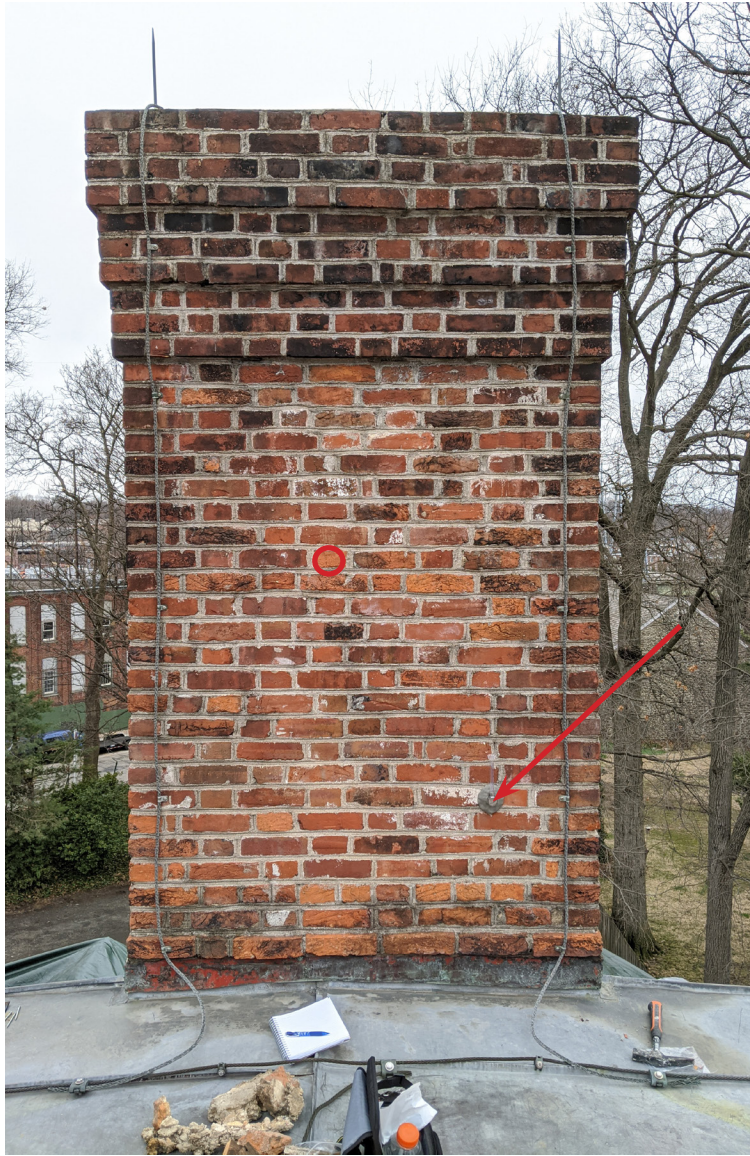
Figure 7 - Northwest chimney with RILEM test location on a mortar joint called out by red arrow and test location on a brick face called out by a red circle

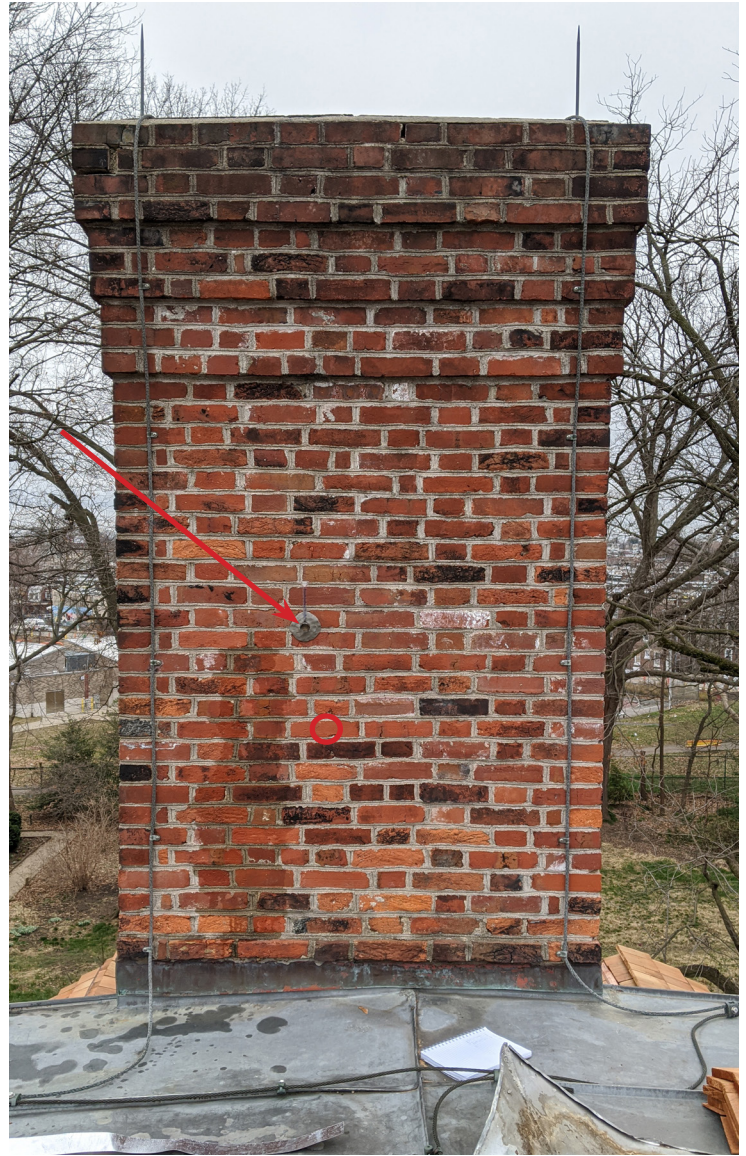
Figure 8 - Southeast chimney with RILEM test location on a mortar joint called out by red arrow and test location on a brick face called out by a red circle

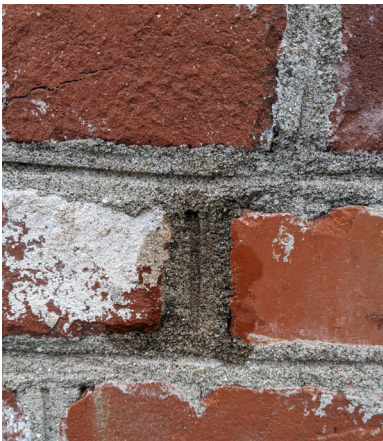
It is important to note the condition of the mortar joints that these tests were conducted on, the joint on the northwest chimney appeared to not be completely sealed, a small crack along the brick face was present. The joint on the southeast chimney appeared to have a mostly solid seal along the brick, with a smaller crack along the brick & mortar interface. As a result, water was absorbed more quickly on the northwest joint, as the larger crack facilitated easier entry. However, after a certain point it appeared that the absorption tapered off and plateaued in both cases. The test conducted on the more solid southeast chimney joint resulted in very slow water absorption.

Figure 11 - (left) RILEM testing site on joint on northwest chimney

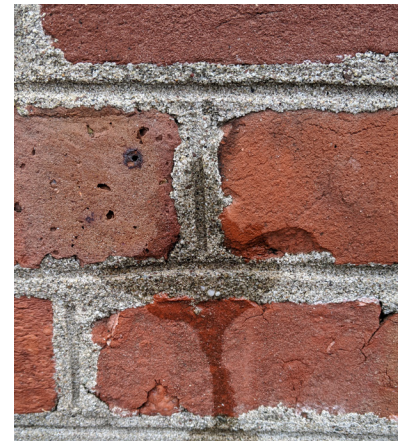
Figure 12 - (right) RILEM testing site on joint on southeast chimney

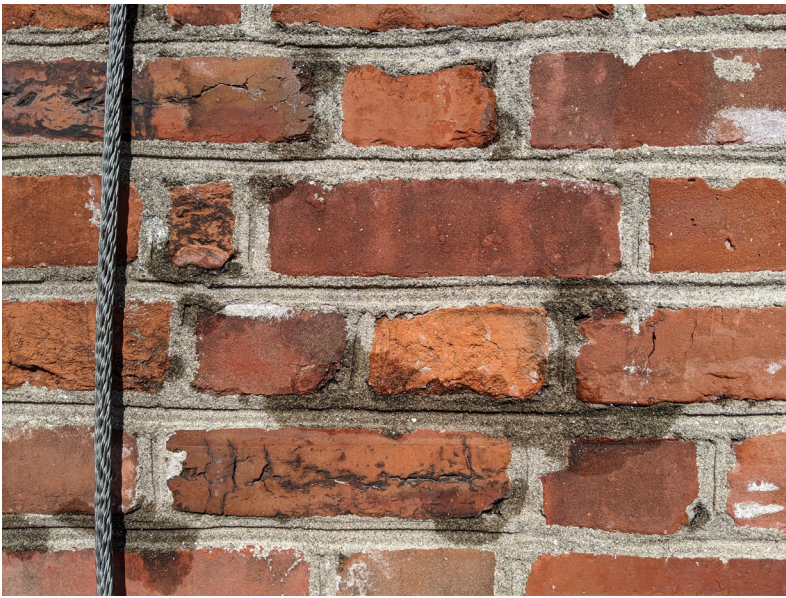
Figure 13 - Water movement through cracks along the mortar/brick interface to evaporate on the warm surface.

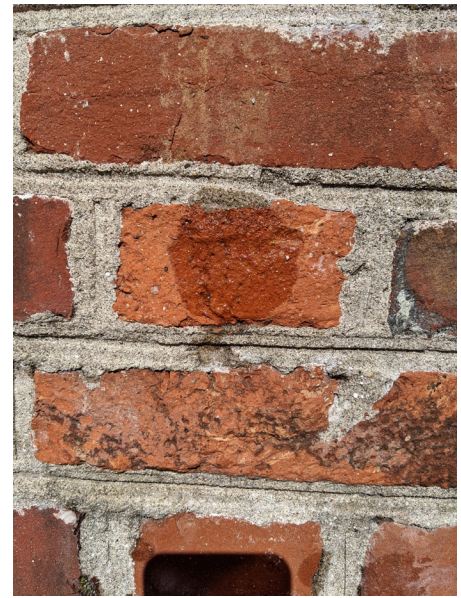
Initially, MC staff believed that this was due to an incompatible mortar made of Portland cement that might not allow for moisture movement as much as a lime mortar, however when the tests were conducted on the brick faces, an even lower absorption rate was found. The rate was so slow that not even 0.5 mL had been absorbed into the brick face after 25 minutes in both cases, and the testing was abandoned due to high winds along the roof. This was contrary to what was anticipated, as the brick face on the northwest lacked a fireskin and therefore should be extremely absorptive. On the second day of investigation MC staff noted water leaking from cracks along the brick/mortar interfaces as it was moving to the warm surface to evaporate (Figure 13). It was sunny and warm, and it hadn't rained in a few days. This, coupled with the very low absorption rate of the brick faces led us to conclude that both chimneys were likely treated with a water repellent coating sometime in the past, likely after the Brumbaugh reconstruction in 1958. Archival information also lends to this assumption, as a water repellent coating was used by Brumbaugh and J.S. Cornell & Son on the wing in 1956. In a letter from Cornell to the Colonial Dames, it was mentioned, "The leak in the toilet room and dampness on the wall of stairs in recently altered building is due to water getting through the masonry walls of light well and through the skylight. This skylight serves no useful purpose so we propose to place plywood over it and place a cold process felt and cement roof and flashings. On the exterior wall of this light well we will apply two coats of Hydrocide Color-Cote."

Figure 14 - RILEM test location on brick face without fireskin on northwest chimney

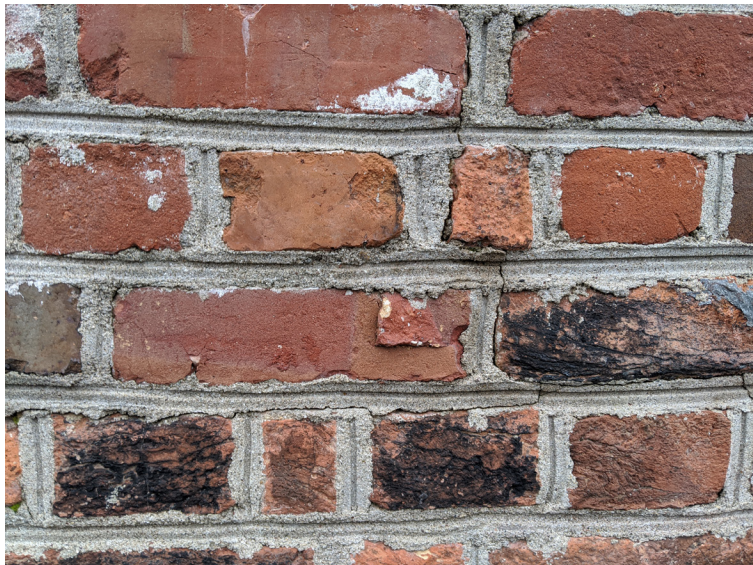
Both chimneys exhibit cracking along the brick/mortar interface, as well as mortar loss/open joints near the tops of the stacks (Figure 15 & 16). These cracks are essentially allowing water to infiltrate to the interior of the masonry and negating any positive effects the water repellent coating had initially provided. Generally, a water repellent coating on historic masonry hinders the natural moisture movement patterns and can trap moisture in the wall. This is apparent at the chimneys, as water was moving to the surface days after a rain instance. However, because the chimney has been sealed below the roofline to accommodate the heating units in the attic, coupled with the fact that most water repellent coatings are generally difficult or impossible to remove without damaging the masonry units themselves, it would be acceptable to allow this coating to remain on the brick faces. However, it is recommended the extant mortar on both chimney stacks which have the water repellent coating be raked out, and repointed with an untreated, NHL 3.5 mix that matches the mortar in the body of the house in aggregate/binder ratio, appropriate aggregate profile, overall color, and pointing type. Both chimneys utilize a grapevine joint which is typical of Delaware Valley 18th century construction, and this should be replicated with the appropriate tools. This new mortar would allow a breathable location for moisture to exit the masonry and close the currently open joints. This mortar replication would require an analysis of the mortar on the lower portions of the house. It is also recommended that RILEM testing be conducted on the main body of the house to discover if a water repellent treatment was used universally on the building, or only on the reconstructed chimneys. This information will inform future conservation treatment approaches.

Figure 15 - Cracks along the brick/mortar interface

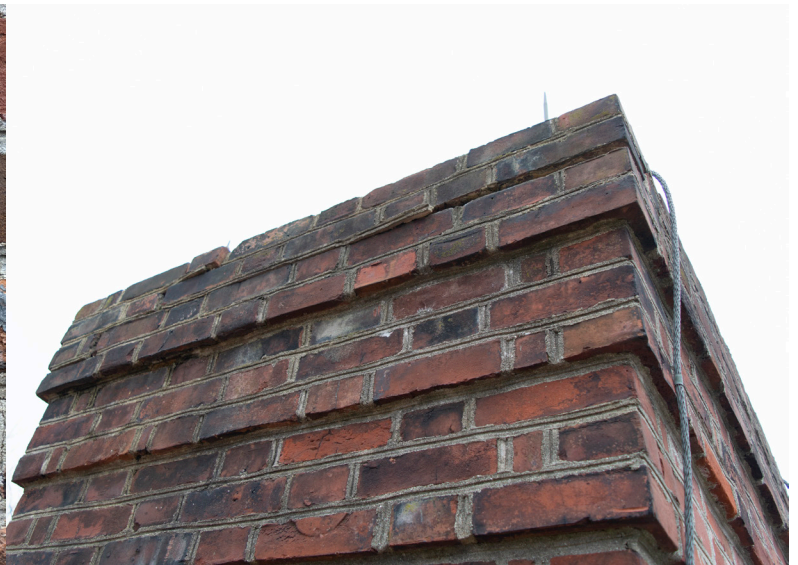
Figure 16 - Mortar moving away from joints, creating open joints allowing water infiltration

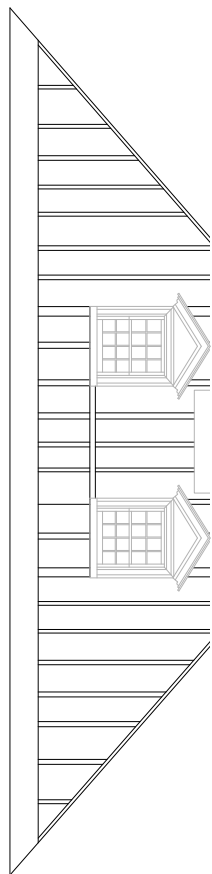
A thorough roof framing survey was conducted by John M. Dickey, one of the foremost restoration architects in the Philadelphia area from the 1960s-1980s, which is included in Stenton's Historic Structures Report (HSR). During the brief investigation of the northwest side roof framing members, MC staff recorded both running measurements and measurements of the joist face, and also took molds of the visible marriage marks on the roof members. One difference between the extant conditions on this side and the Dickey roofing plan was that there are **three** rafters between the dormers rather than the two that are pictured in the Dickey plan. Overall, the roof framing members appear to be in good condition with no visible rot.

Figure 25 - As-found joists on NW elevation

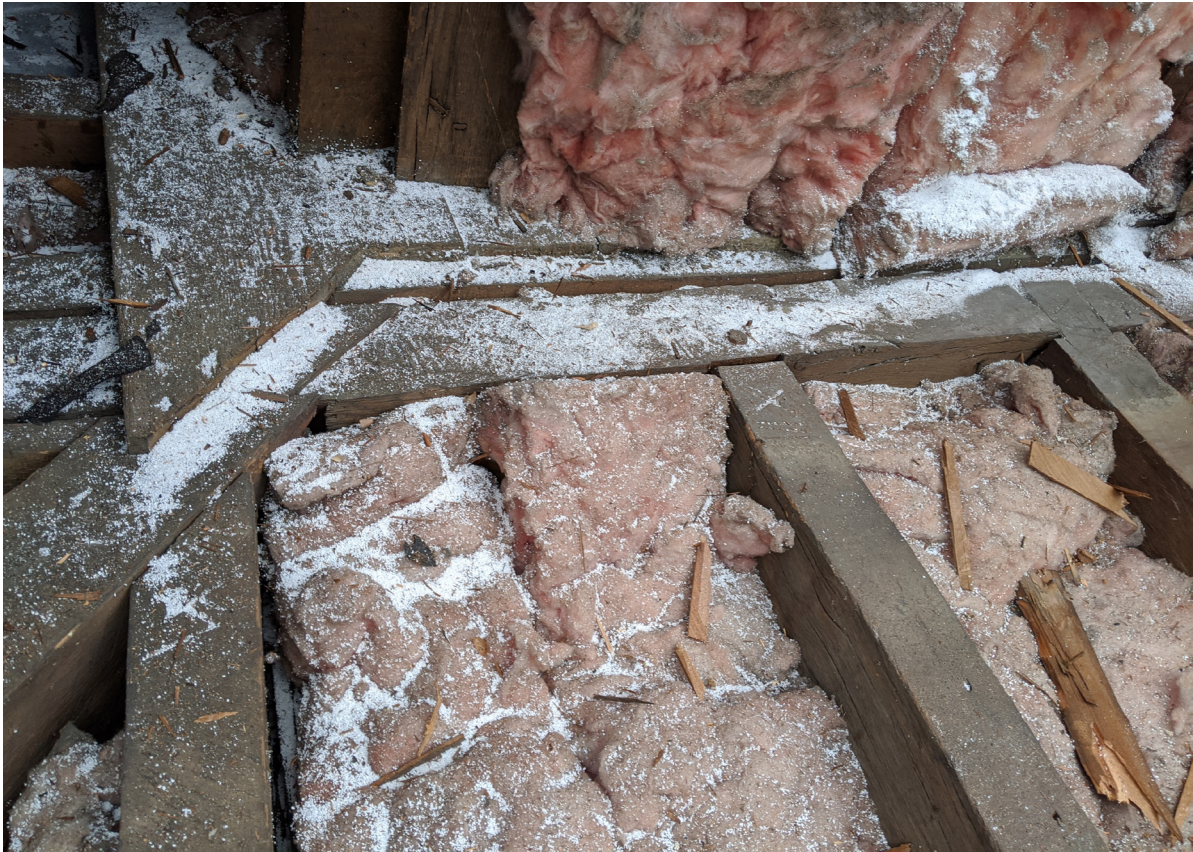
Dickey continued to lay out the roofing scheme in the HSR, however MC staff were not able to confirm some of these details in the field due to restraints on what roofing material was exposed. MC staff did confirm the layout of the corner between the northwest and southeast elevations, observing the first joist connected to a diagonal member spanning corner to outlooker, the second joist connected to the outlooker by a tusk tenon, and the rest of the intermediary joints utilizing a lapped dovetail, as depicted below. A lower, secondary tenon was also utilized on all the joists connected to the outlooker.

Figure 27 - As-found conditions of 3rd floor ceiling joists to outlooker.

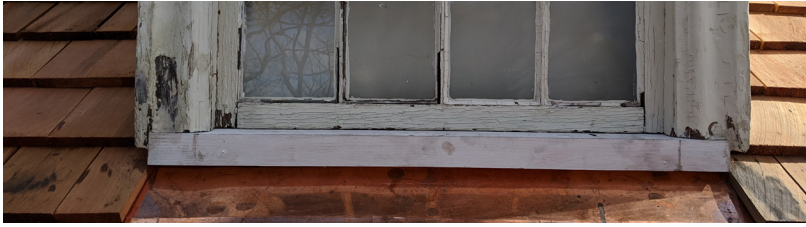
Due to accessibility restrictions, only the southwest and northwest elevation dormers were available for hands-on condition assessment, the other elevation dormers were assessed visually. The two flanking dormers on the southwest side appeared to be new, and the middle one found to be sound and recently patched, likely during the contemporaneous roofing procedures. The two southeast dormers also appeared to be new, as did those on the northeast elevation. The ones on the northwest side had signs of rot and deterioration, however the roofers had not yet reached that area during MC observation. If they were not replaced or fitted with a dutchman repair during the reroofing procedures, it is recommended that this be completed. More pressingly, the window sashes themselves appeared to require conservation work, particularly on the southern sides. Failing and missing glazing, wood deterioration, slight member racking, and general paint failure were noted. A sash on the southeast elevation appeared to be missing a pane of glass altogether. Again, if these conditions were not addressed during the final stages of the reroofing process, it is highly recommended that these sashes receive conservation attention.

*Figure 29 - (top) West dormer sill on SW elevation*

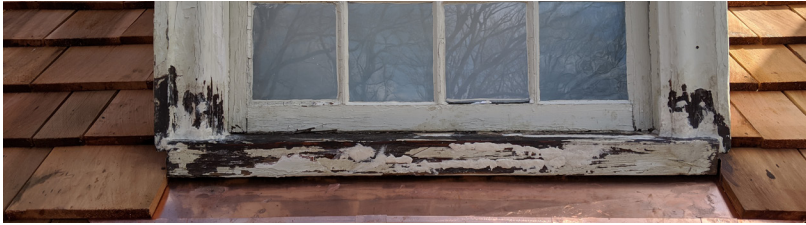
*Figure 30 - (middle) Central dormer sill on SW elevation*

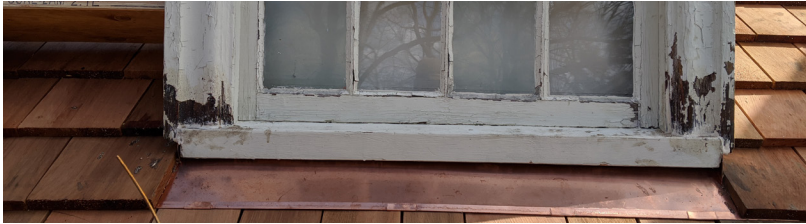
*Figure 31 - (bottom) East dormer sill on SW elevation*

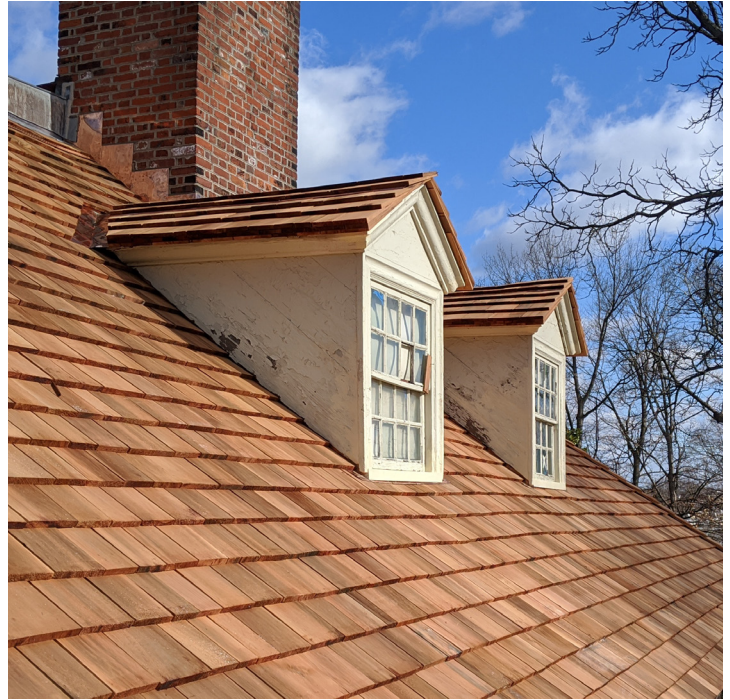
*Figure 32 - Dormers on SE elevation*

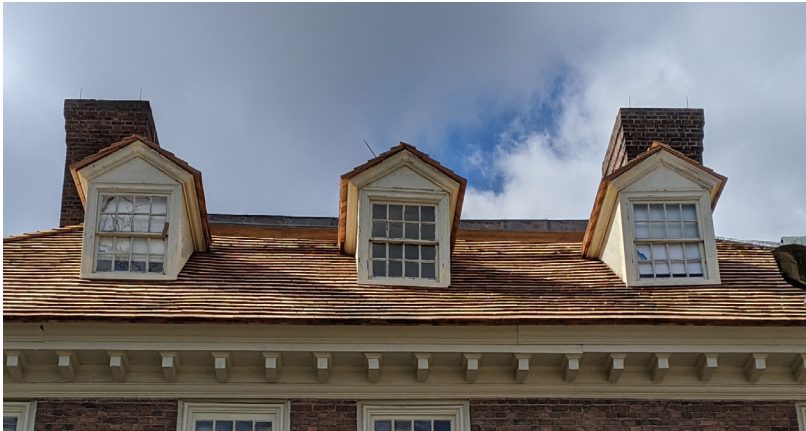
*Figure 33 - Dormers on NE elevation*

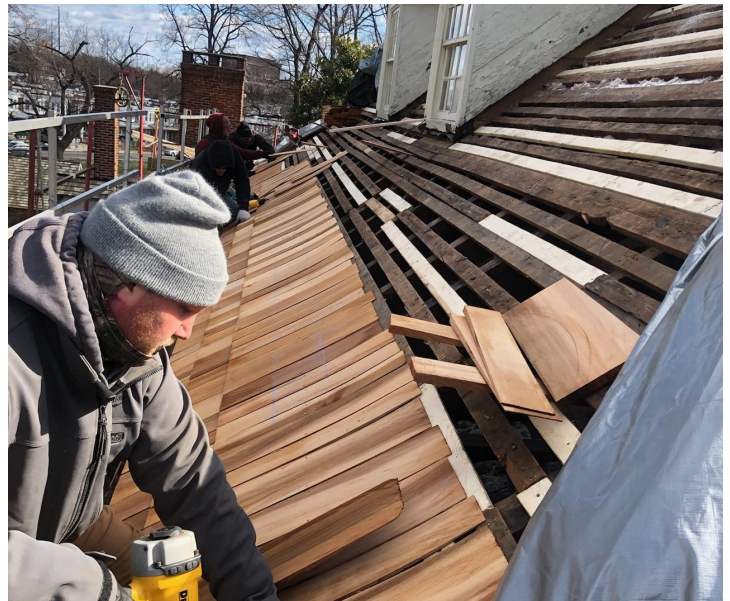
*Figure 34 - Dormers on NW elevation*

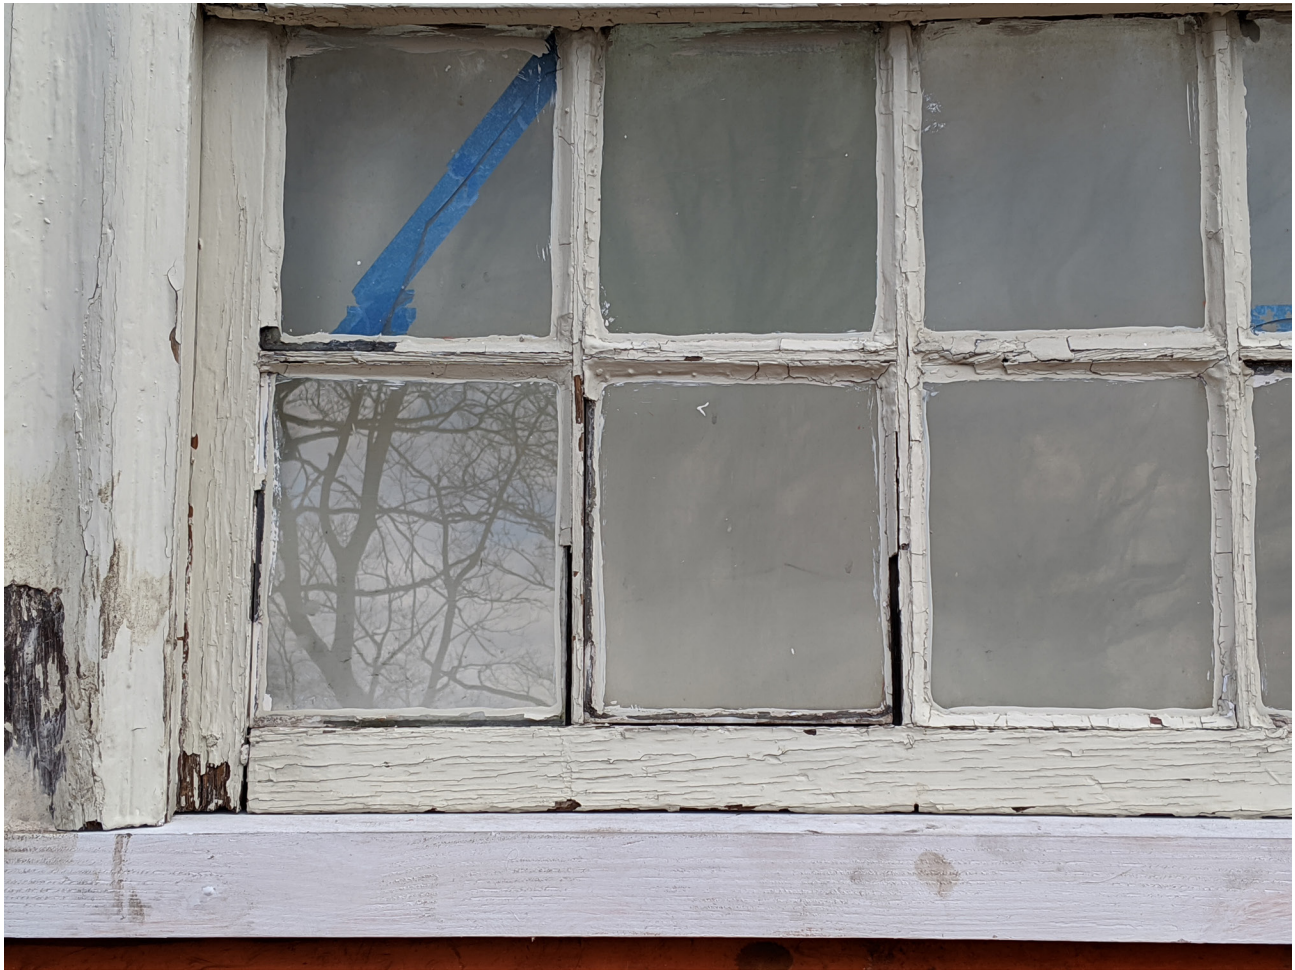
*Figure 35 - Failing paint and glazing on east window of SW elevation*

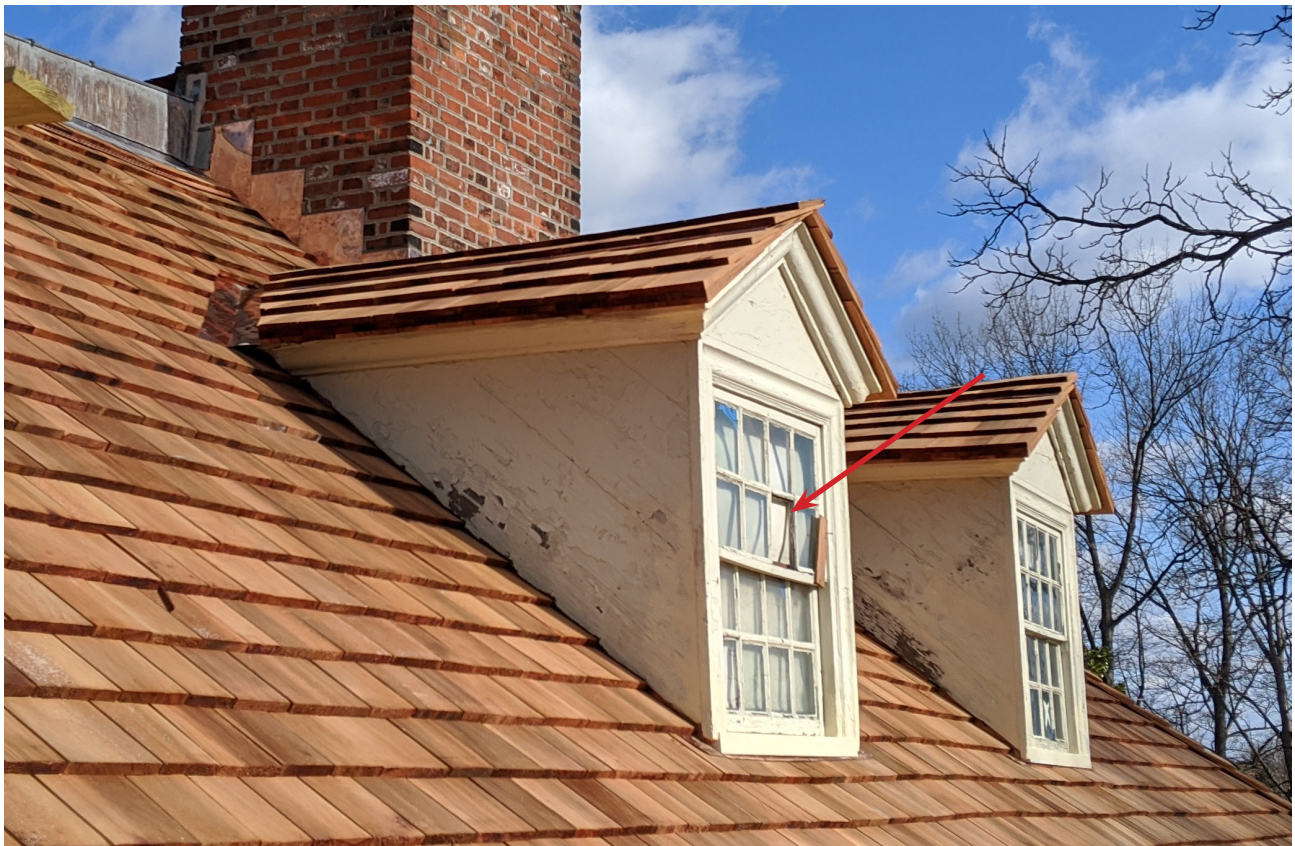
*Figure 36 - Missing pane of glass on SE elevation indicated by red arrow*

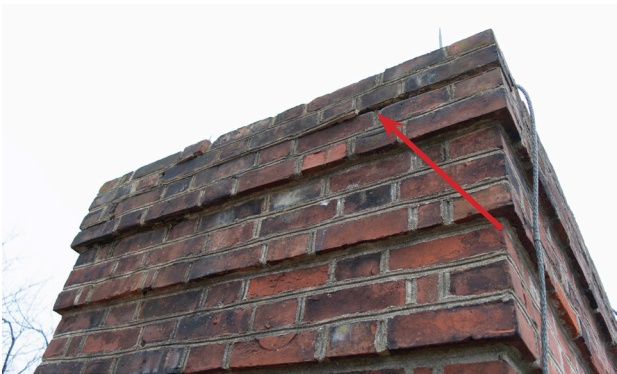
The mortar sample is off-white in color and moderately hard. The exterior surface is weathered, with exposed aggregate grains. Microscopic examination of the sample under 10x magnification shows some very small clumps of partially dissolved lime in a moderate to dense binder matrix with similar sized aggregate particles.

Figure 3 - Sampling area on northwest chimney called out with red arrow

The approximate reconstruction mix probably contained lime and aggregate. The aggregate is very poorly sorted. An appropriate replication mix would be a standard 3:1 aggregate to NHL 3.5 mix in a color that matches the clean pointing mortar in the body of the house. The replacement aggregate should display a more even distribution of particle sizes.

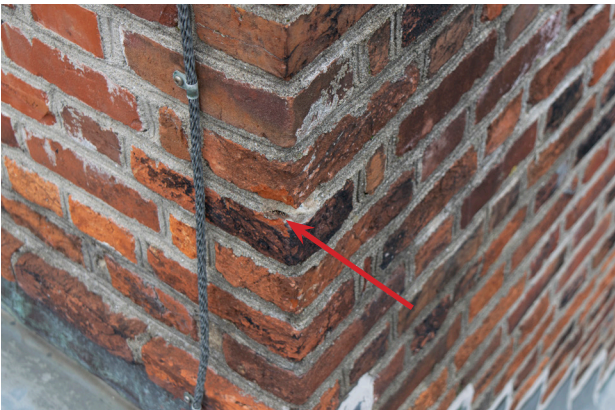
The mortar sample is off-white in color and moderately hard. The exterior surface is weathered, with exposed aggregate grains. Microscopic examination of the sample under 10x magnification shows some very small clumps of partially dissolved lime in a moderate to dense binder matrix with similar sized aggregate particles.

Figure 3 - Sampling area on southeast chimney called out with red arrow

The approximate reconstruction mix probably contained lime and aggregate. The aggregate is very poorly sorted. An appropriate replication mix would be a standard 3:1 aggregate to NHL 3.5 mix in a color that matches the clean pointing mortar in the body of the house. The replacement aggregate should display a more even distribution of particle sizes.
